APOLLO 12

LUNAR SURFACE MAGNETOMETER ANOMALIES

INVESTIGATION OF THE OCCURRENCE OF A "Y" AXIS OFFSET

SSM-13-1399

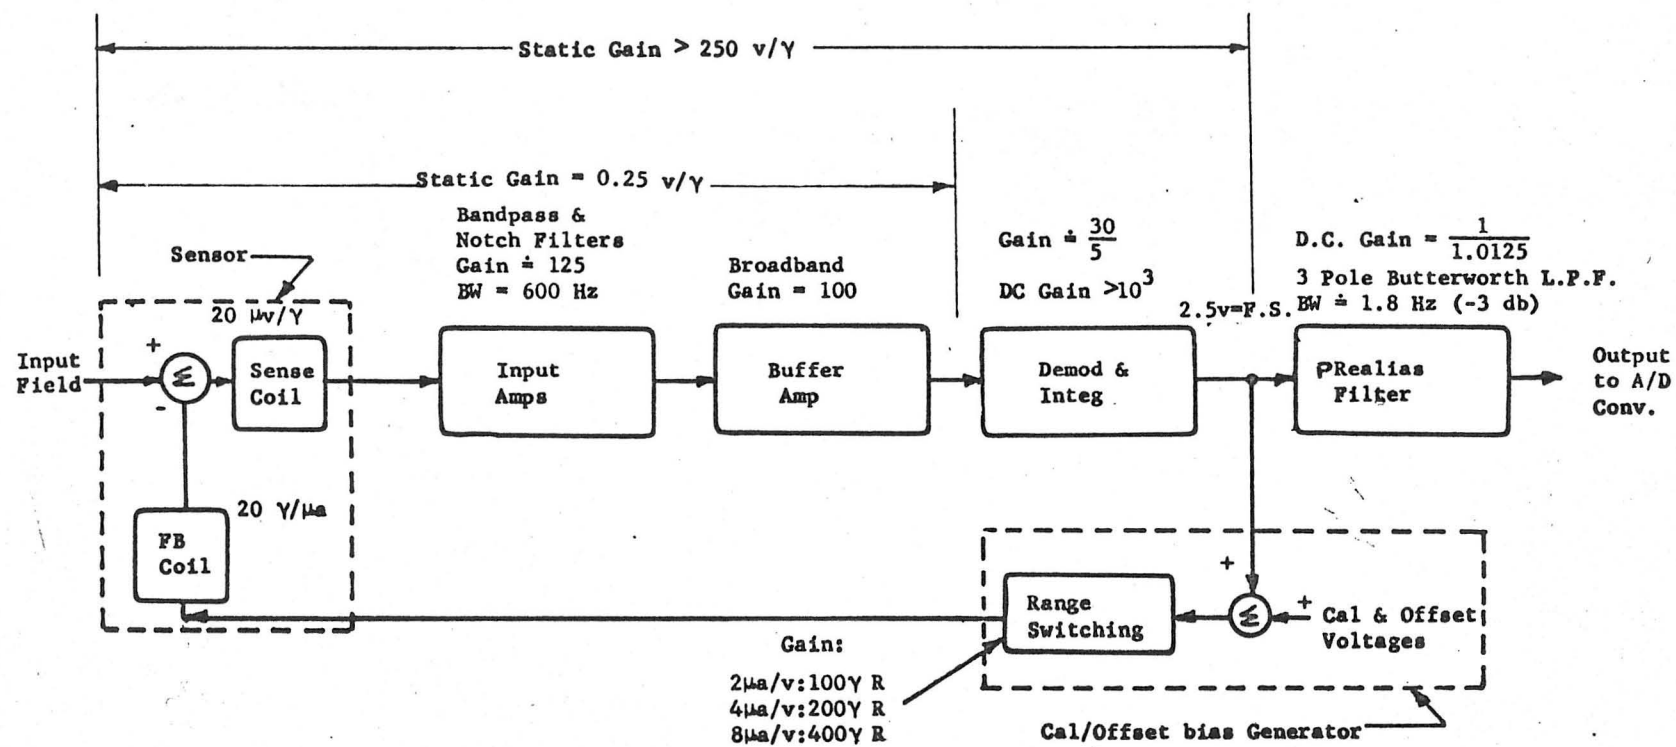
Fig. 1

The failure first manifested itself on the 100 gamma range as a fullscale, -100 gamma offset. When the range was changed to the 200 gamma and 400 gamma ranges the offsets were -50% and -25% respectively. When a Flip/Cal was initiated this function was performed correctly showing the proper steps of +25%, +50% and +75%. The 180° flip rotated the offset vector which indicated that the anomalous offset is associated with the sensor channel electronics and is not externally generated. A schematic of the sensor channel electronics is shown in Figure 1. The fact that the percentage amount of the offset changes with range precludes the failure occurring after the input to the prealias filter. That is if the failure occurred after the input to the prealias filter and caused a fullscale offset on the 100 gamma range it would cause a fullscale offset on the 200 gamma and 400 gamma ranges as well.

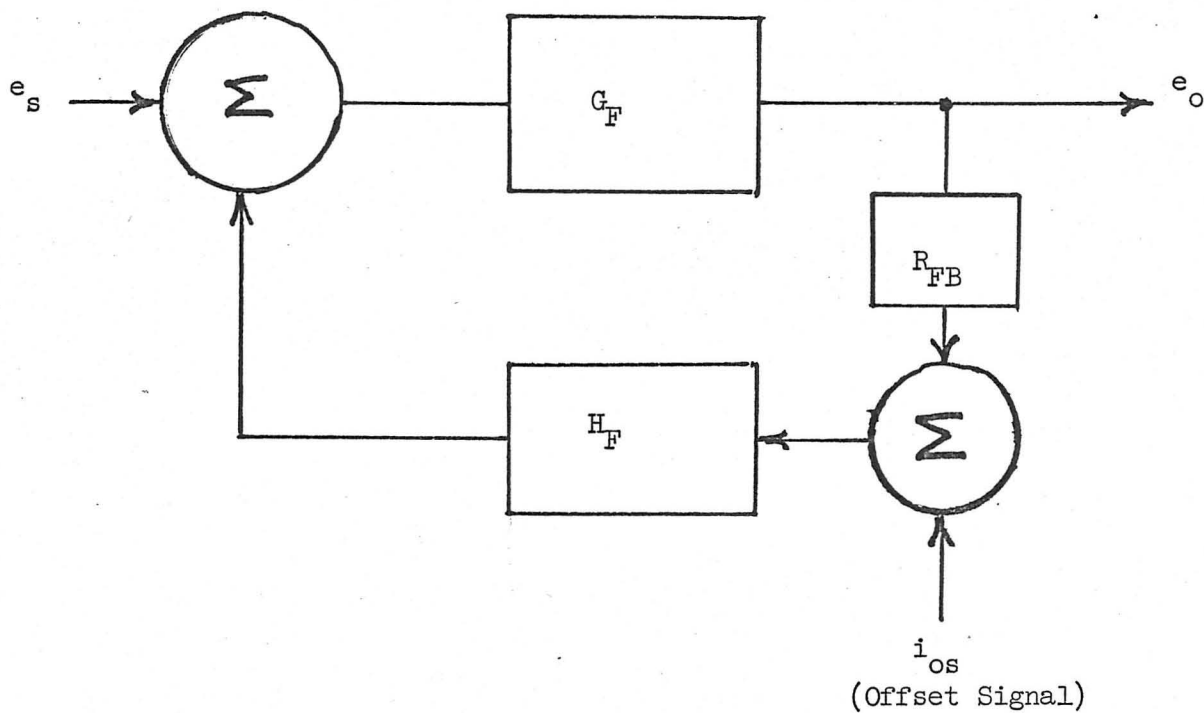
Figure 2

If the failure occurred in the feedback path, in the Cal/Offset ladders or range switching of the Cal/Offset bias generator the offset would appear as a constant percentage of the range. This can be seen from analysis of the simplified schematic shown in Figure 2.

would change and this change could be detected by observing the changes in the Cal raster. Since no change in the Cal raster was observed the failure did not occur in the feedback path.

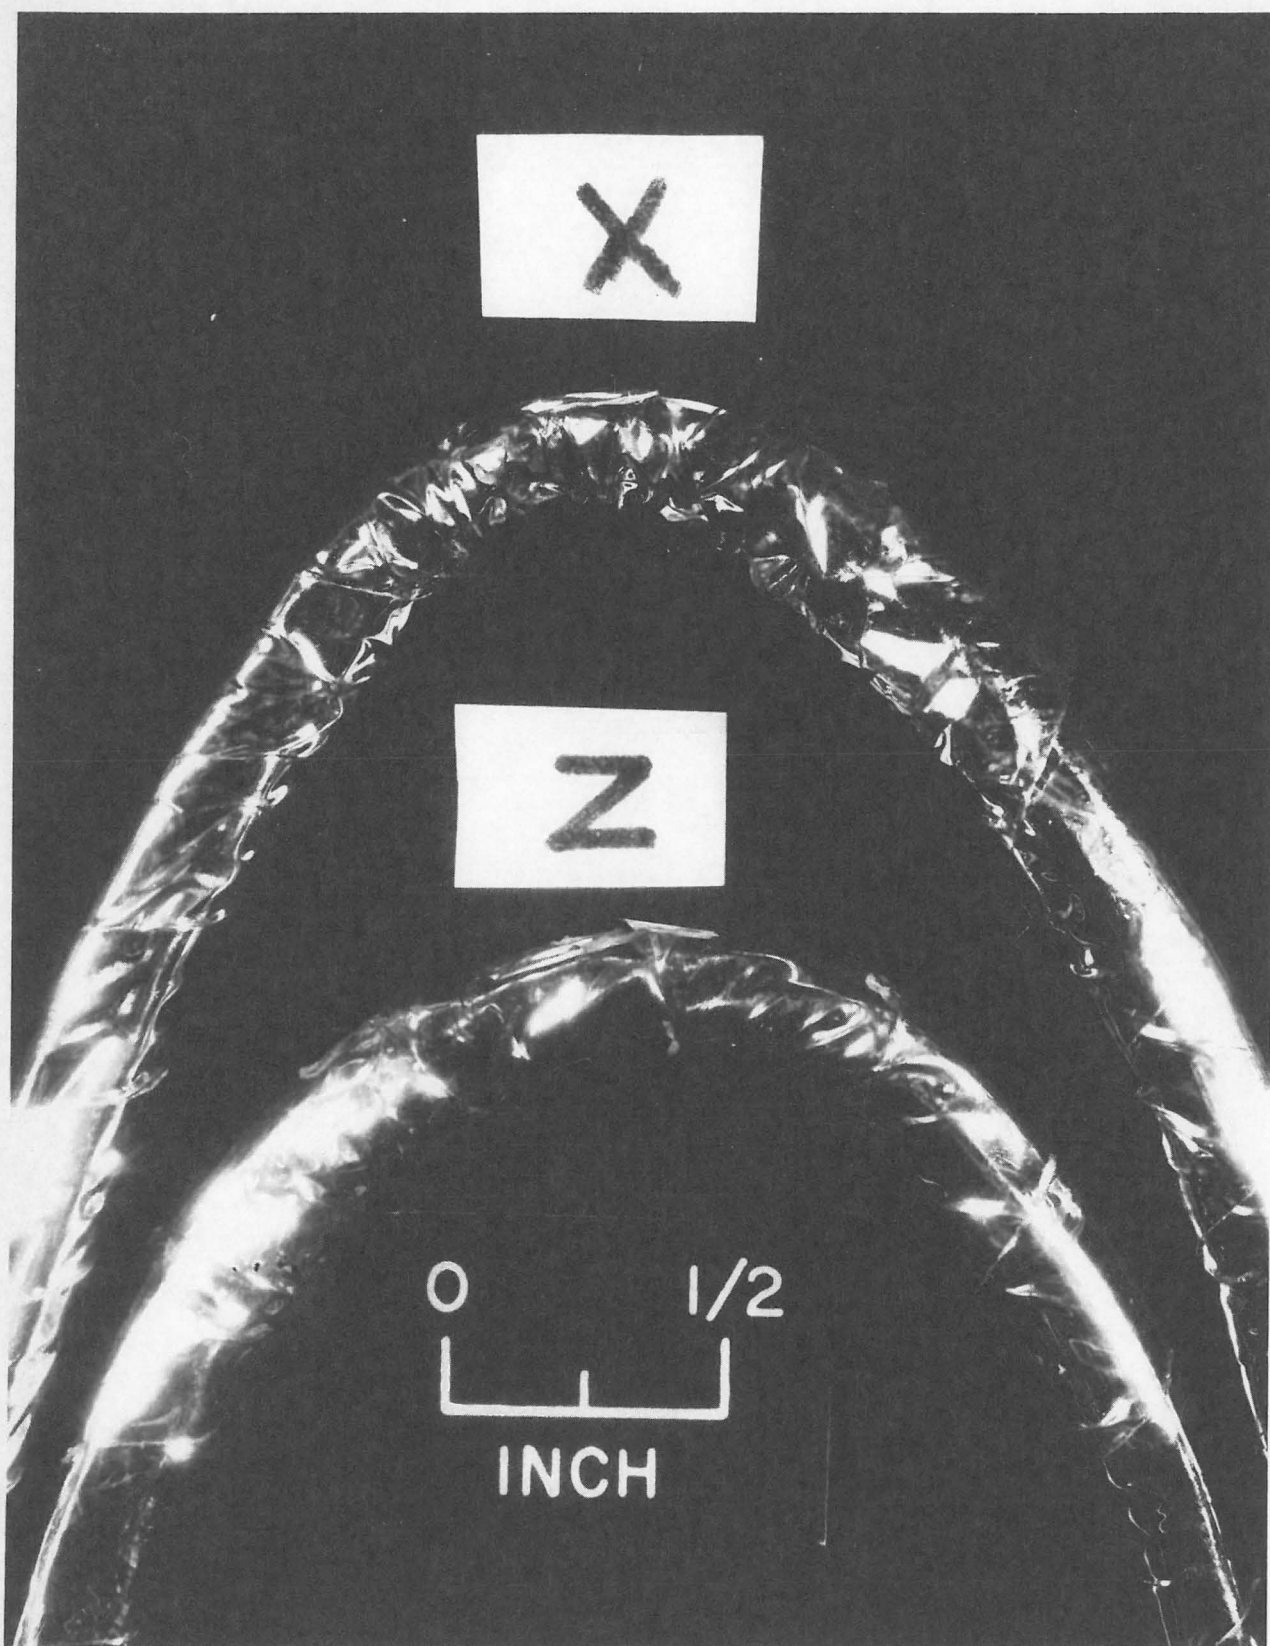
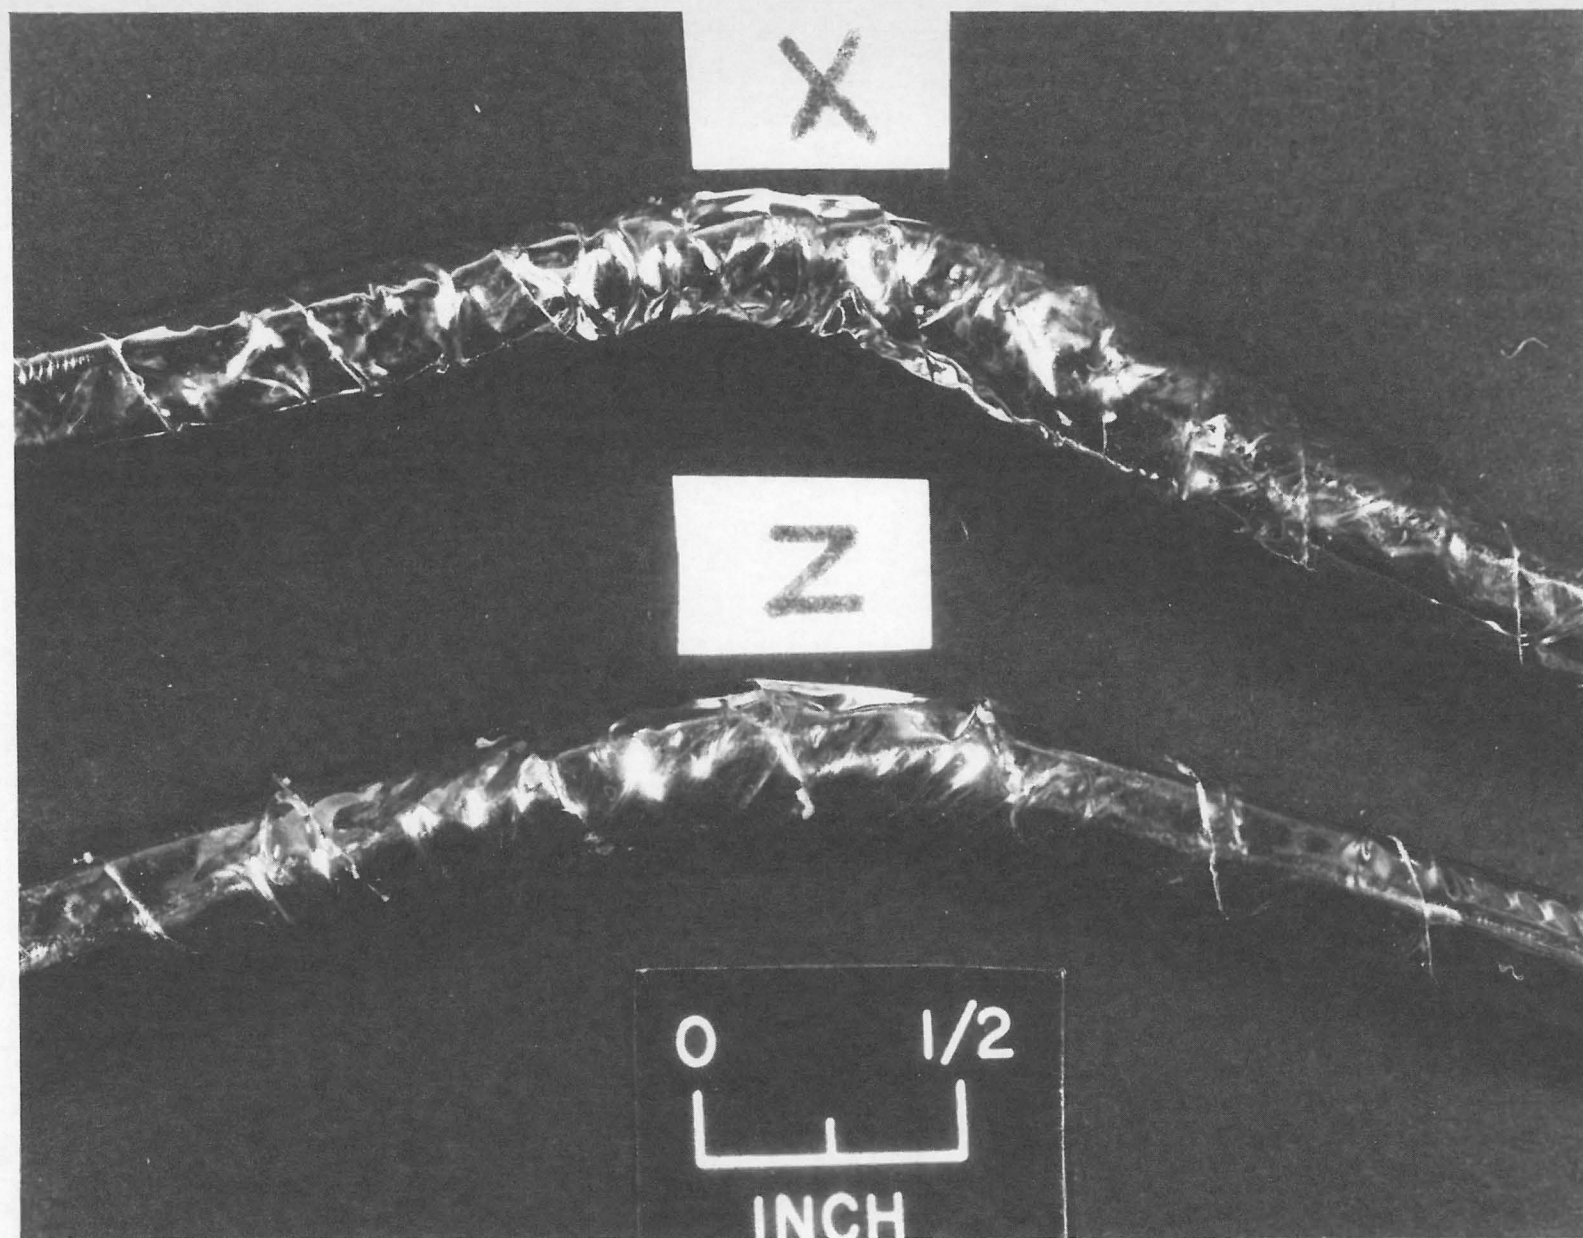
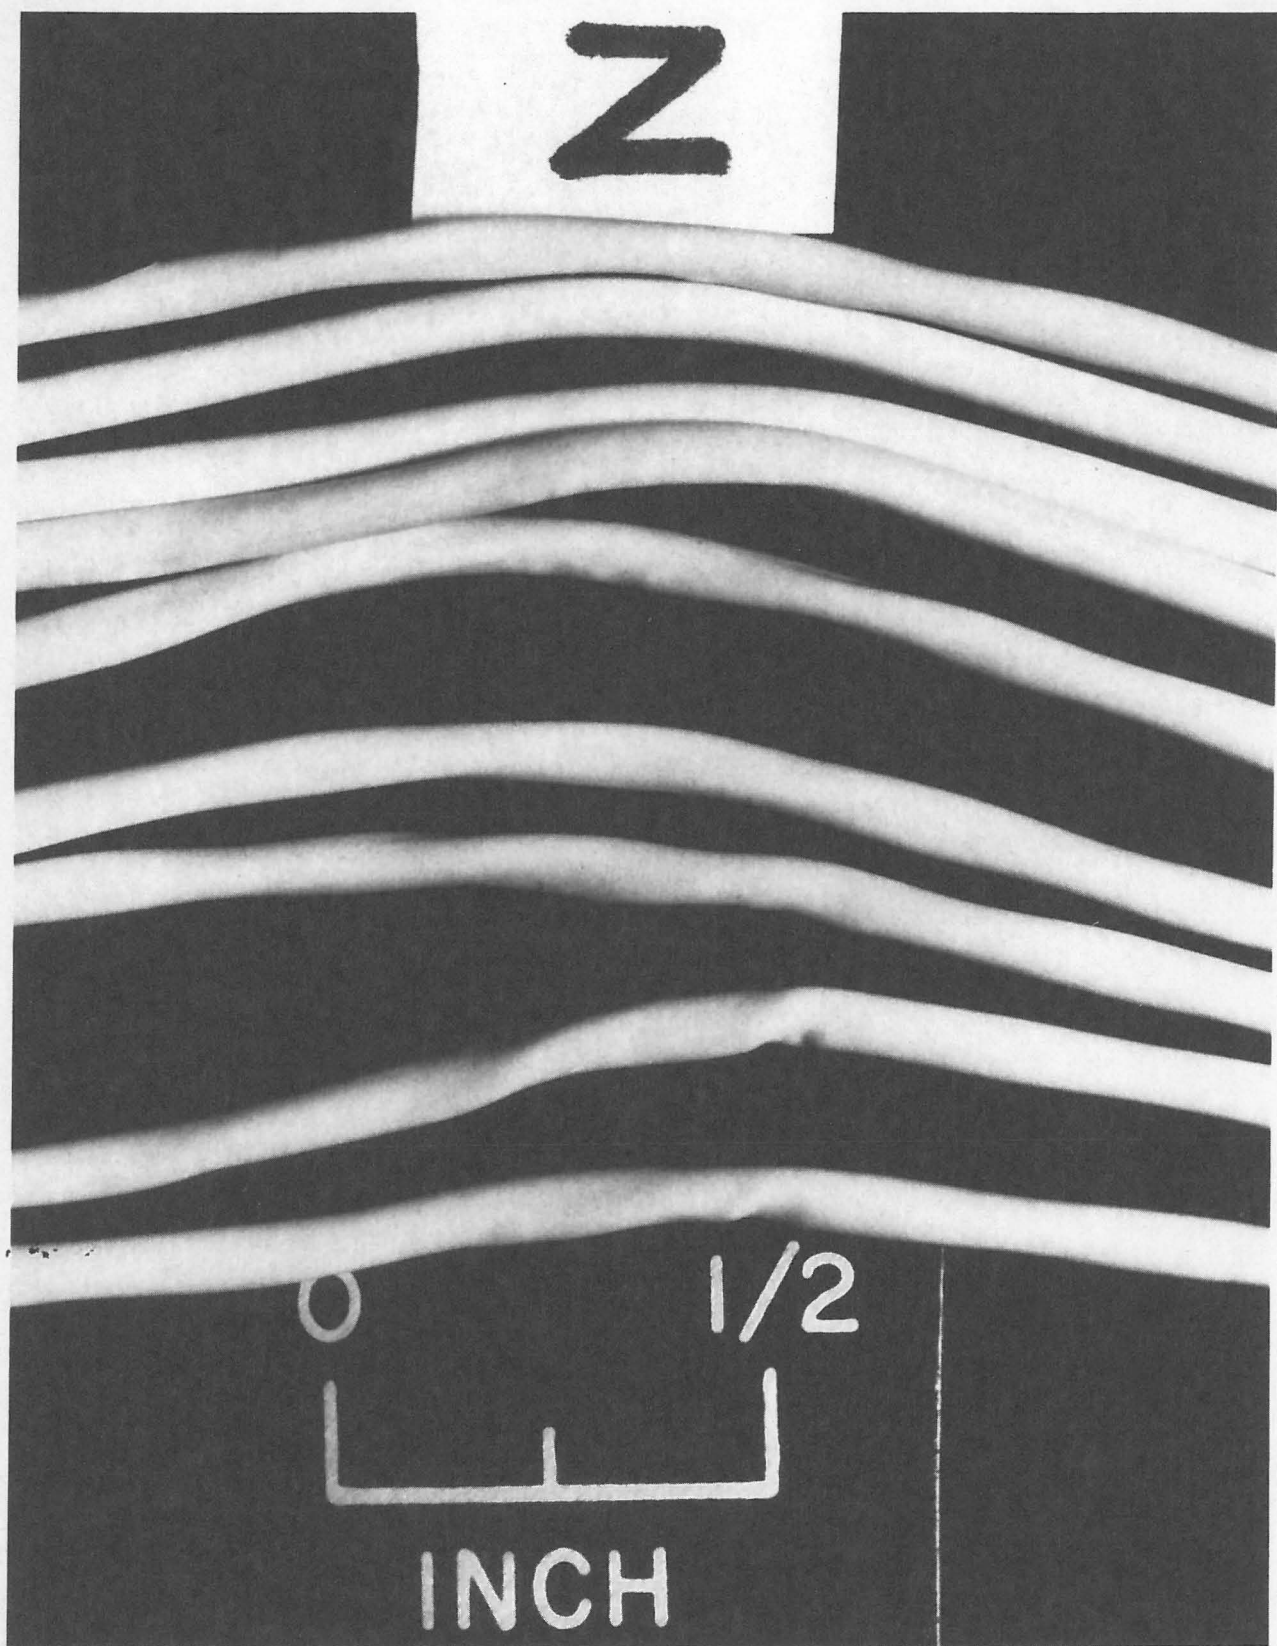
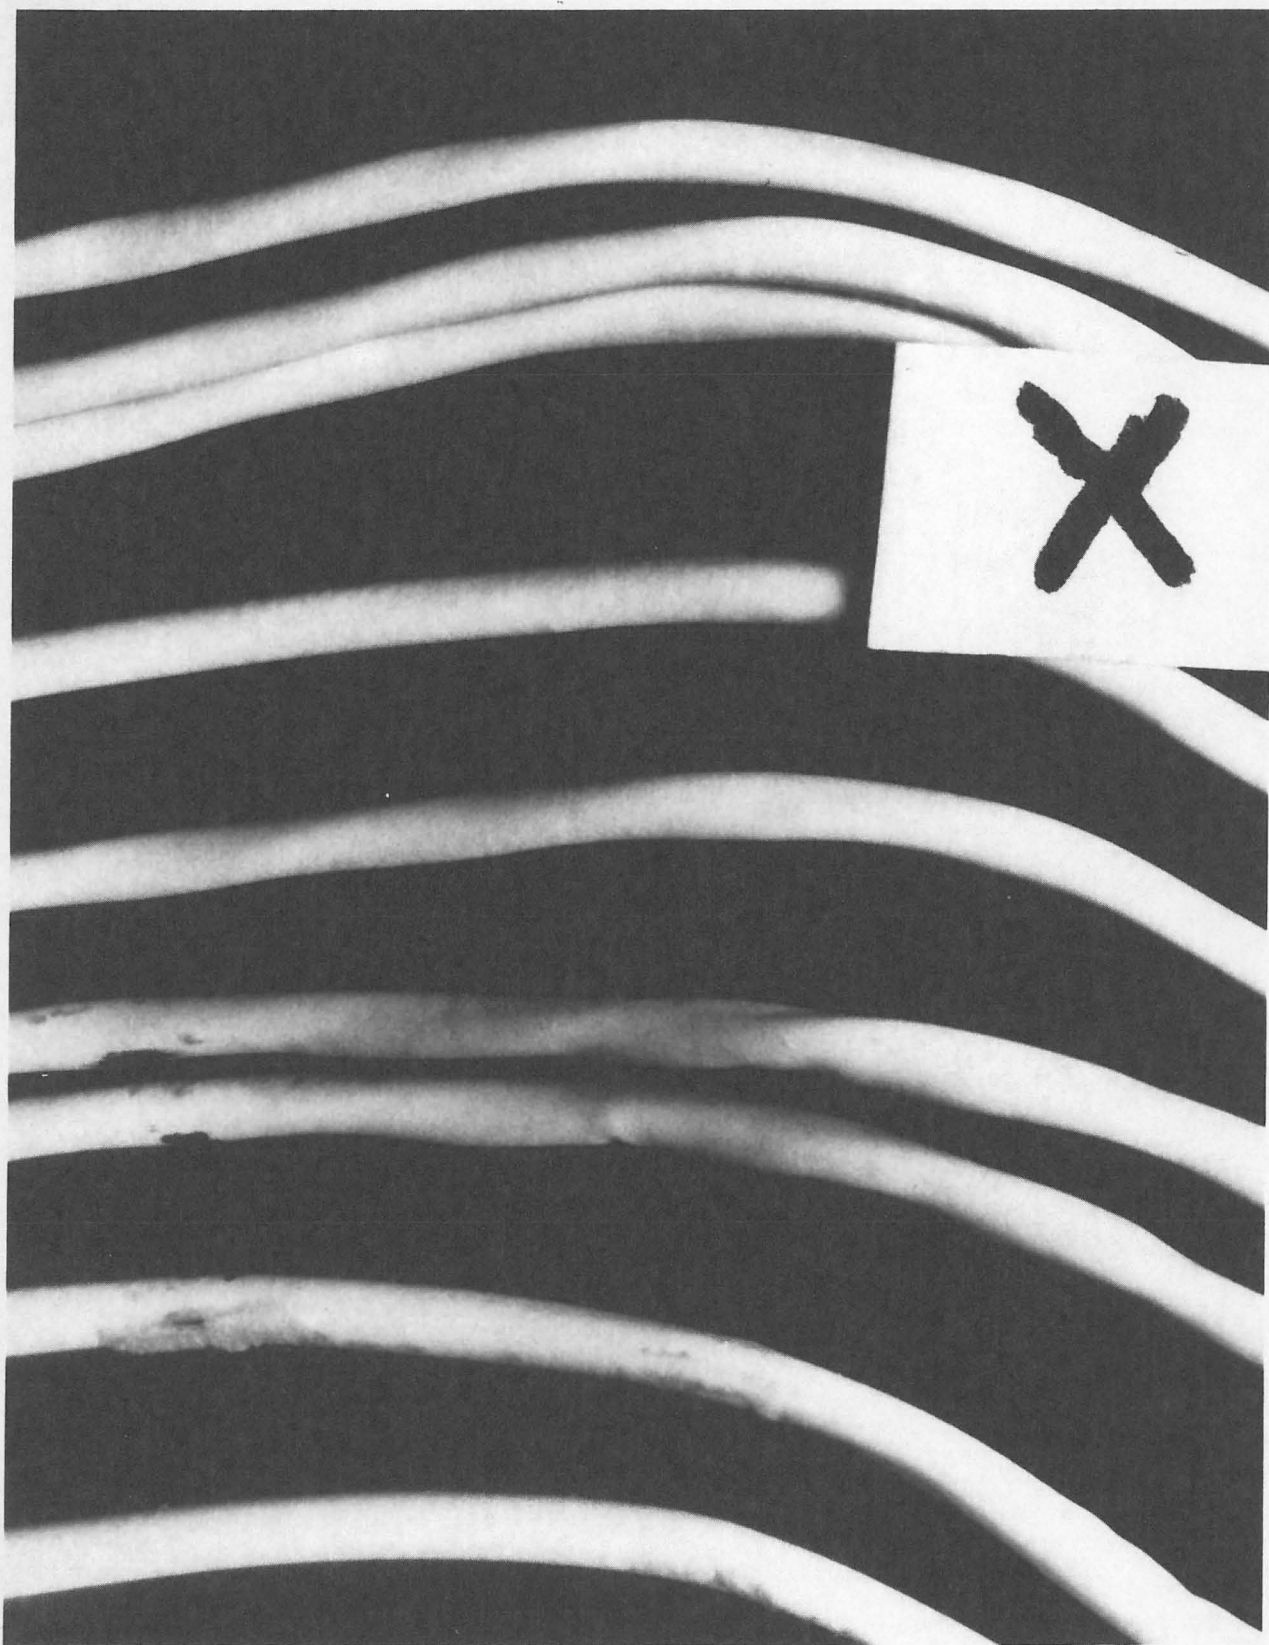
X AND Z ARM CABLE PHOTOGRAPHS

2. The outer insulation and shield were removed from all eighteen wires or pairs for approximately three inches centered at the arm elbow joint. The insulation was deformed in some instances, particularly on those wires located in the bundle at the inner radius of the bend at the elbow. None were deformed as badly as the wire which had broken in the Y arm. Of the 18 shields, all but two had one or more broken strands at the bend. Many had one or two strands broken, a few had three or four, and in three, half or more of the strands had broken.

3. The insulation was then stripped from some of the pairs and the insulation, inner shield, and inner insulation stripped from some of the single conductor wires. (All wires were seven strand). In all cases the wires chosen were those which appeared to be the most badly deformed. The inner shields were found to be undamaged and no broken strands were found in the conductors. It is concluded that for some unknown reason, bending deformations and stresses in the Y arm cable were more severe.

A 70-1433	X and Z Arm Cables - Folded Position
A 70-1434	X and Z Arm Cables - Unfolded Position
A 70-1435	Z Arm Cable - Tape Wrapping Removed
A 70-1436	X Arm Cable - Tape Wrapping Removed

Because of the damage evident in the Y arm harness and the history of many flexures of the arms of this instrument, the decision was made to replace all three harnesses in LSM #4 and to grossly reduce arm flexures of all instruments in the future. (Ref. Philco-Ford RMR 57710). Because LSM  
#7 had had much less use, arm cables in this instrument were not changed.
